UNESCO ASIA-PACIFIC HERITAGE AWARDS
for Culture Heritage Conservation
2003 ENTRY FORM

Conservation of the Catholic Cathedral of the Immaculate Conception, HKSAR

16 Caine Road, Mid-Levels, Hong Kong Special Administrative Region, China

Date of Completion of the Project (must be post-October 1991) 8 December 2002

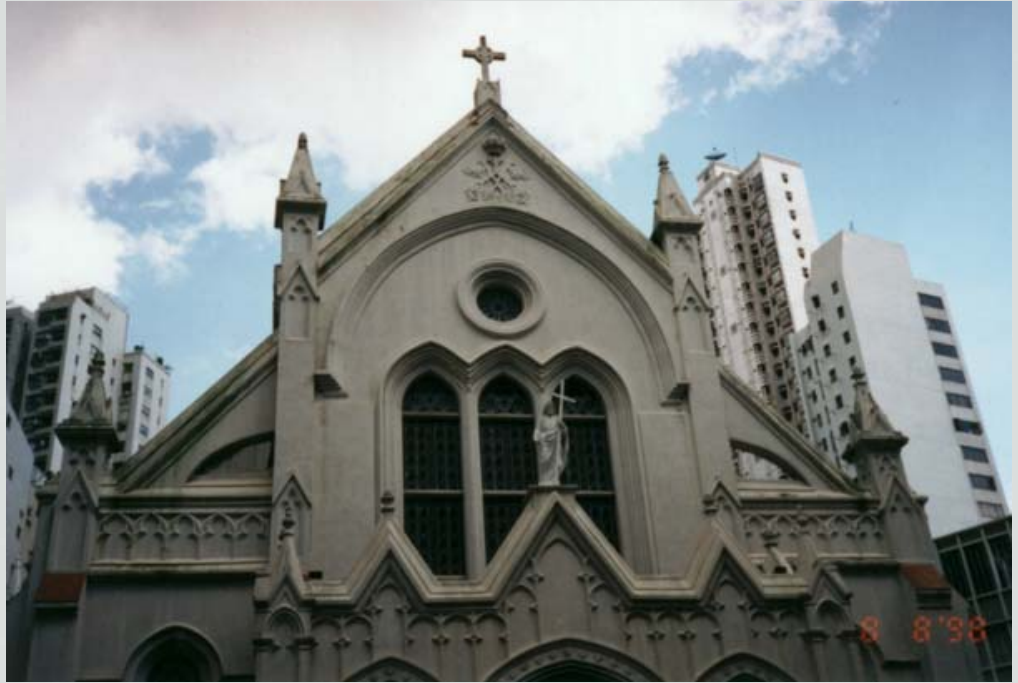
Before - External view

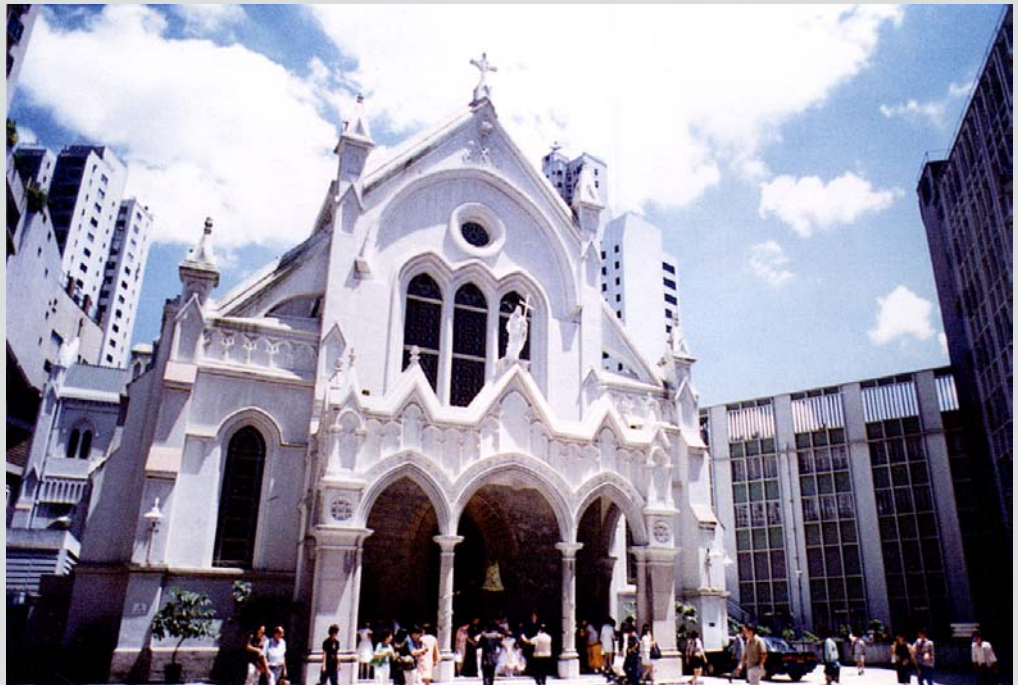
After - External view

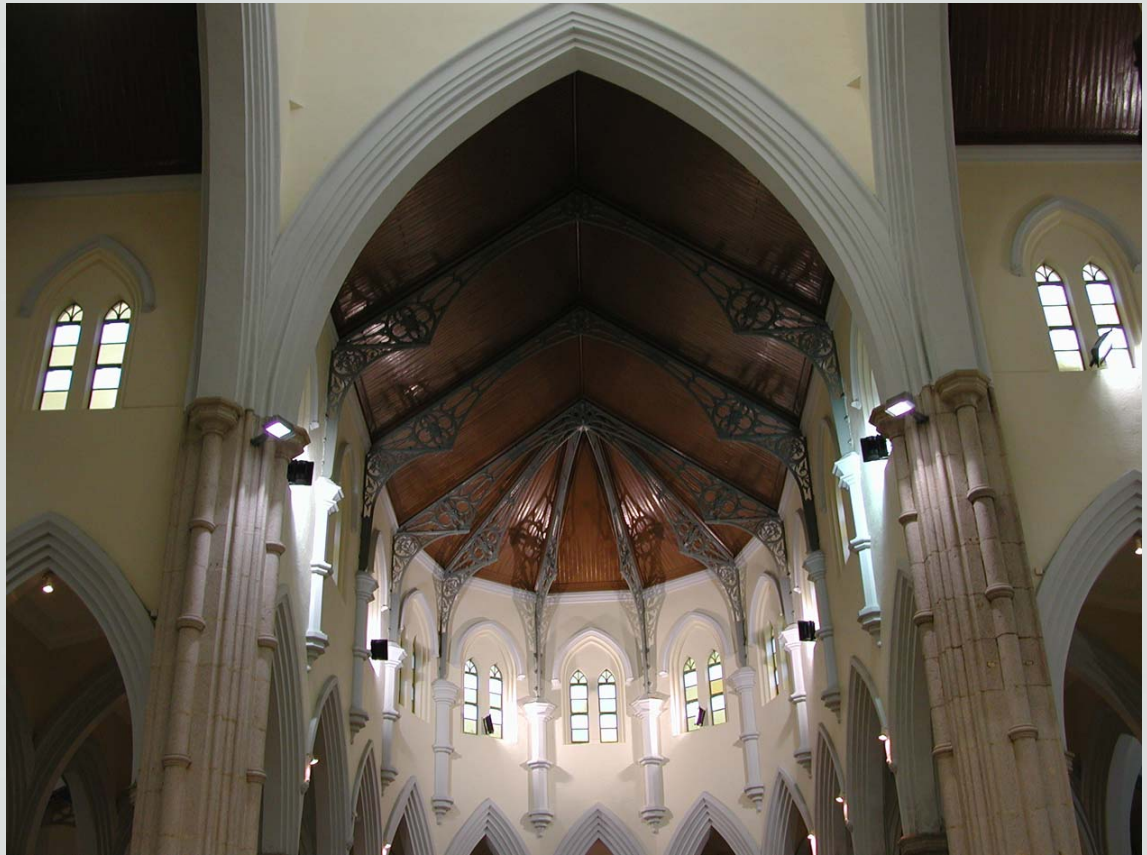
Before - View towards the Apse

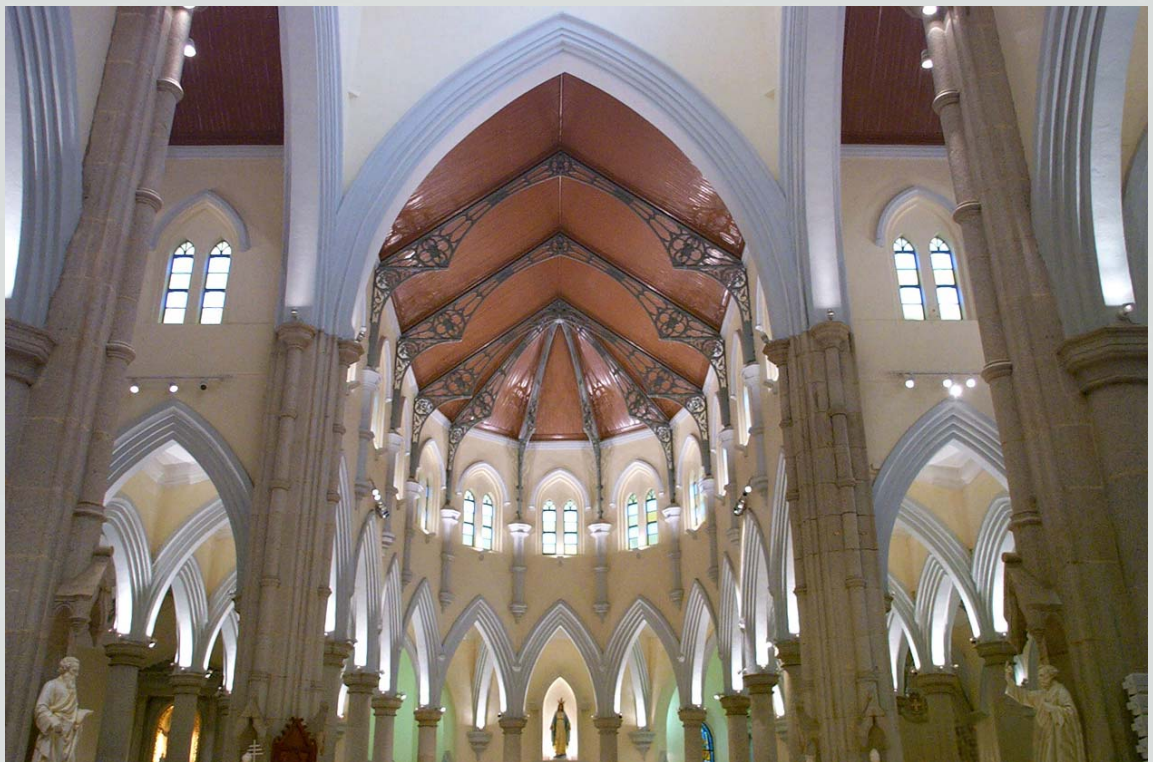
After - View towards the Apse

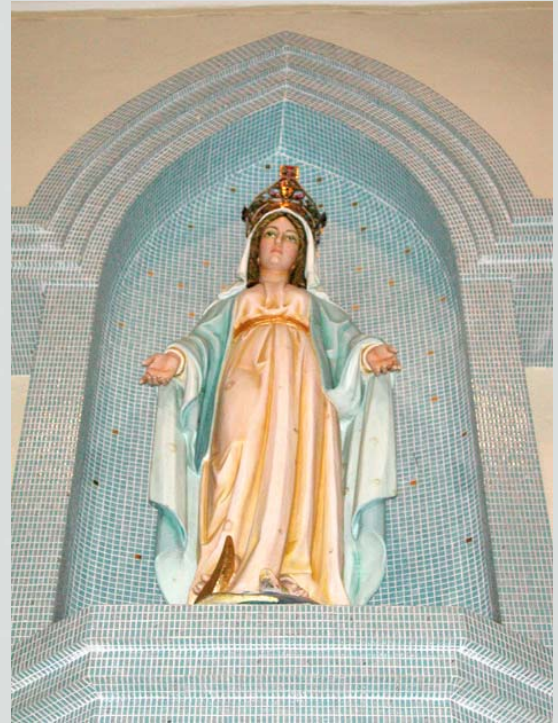
Before - Niche of the Immaculate Conception

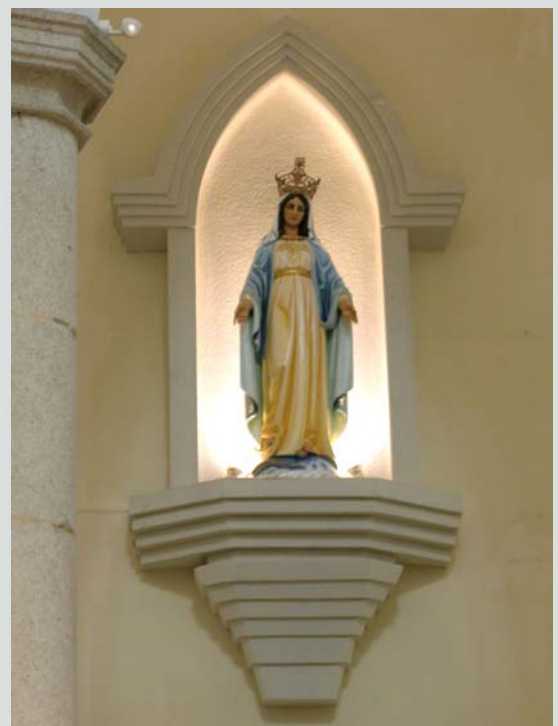
After - Niche of the Immaculate Conception

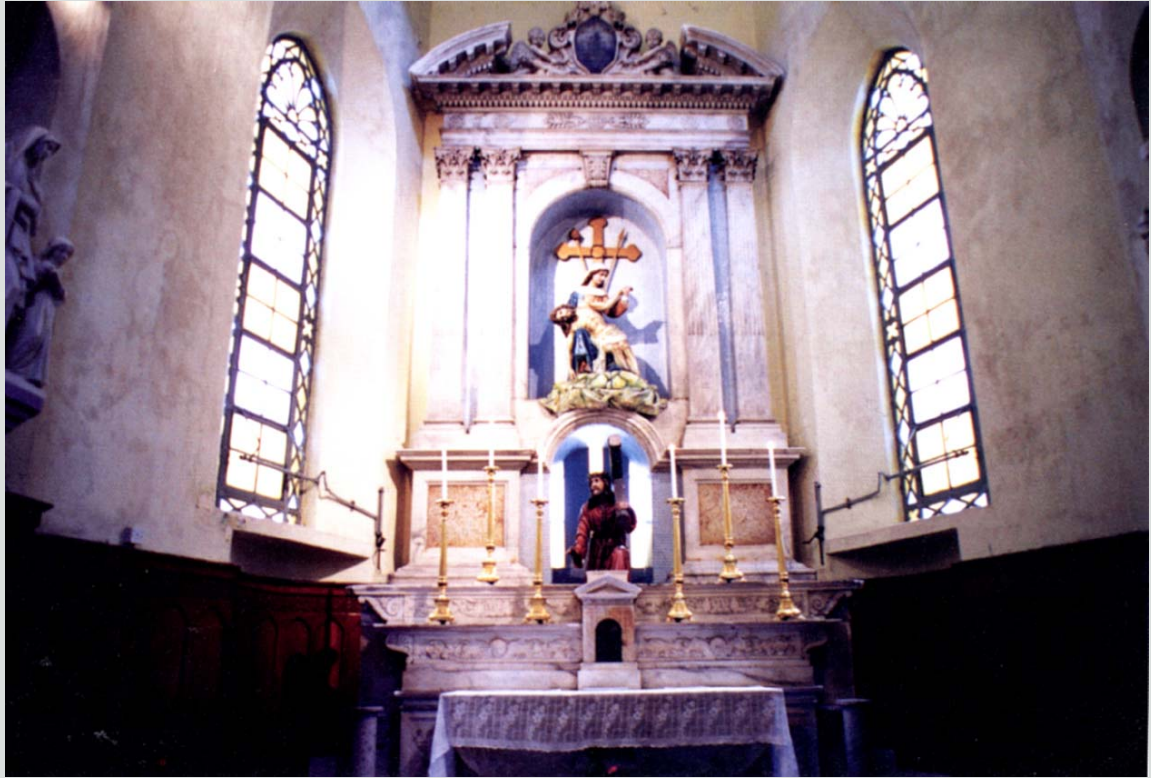
Before - The Chapel of our Lord's Passion

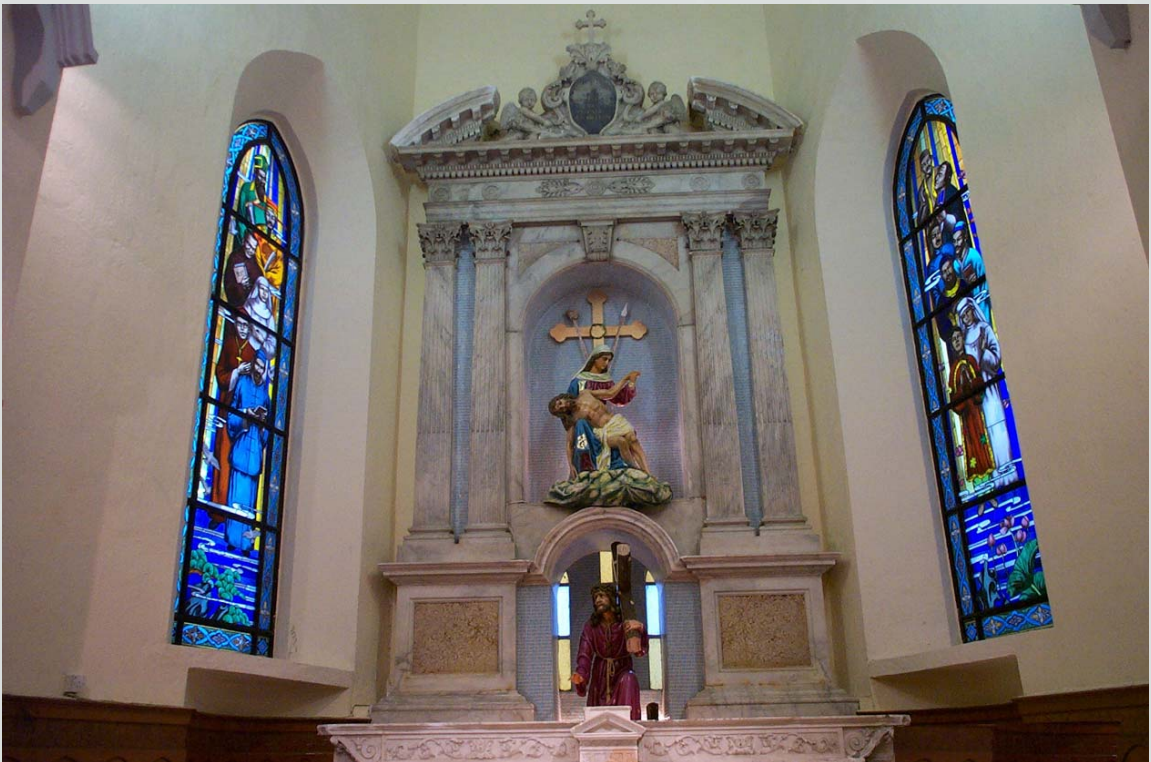
After - The Chapel of our Lord's Passion dedicated to the Chinese Martyrs

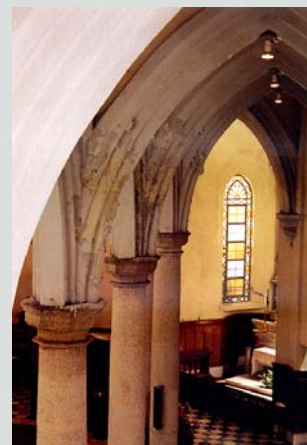
Serious roof leakage at 1997

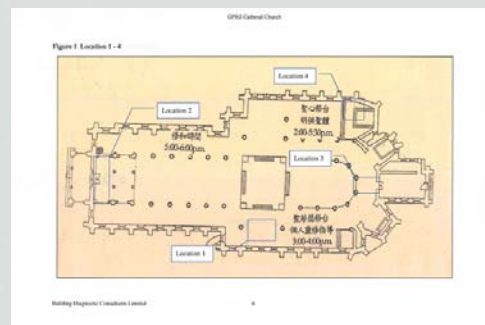
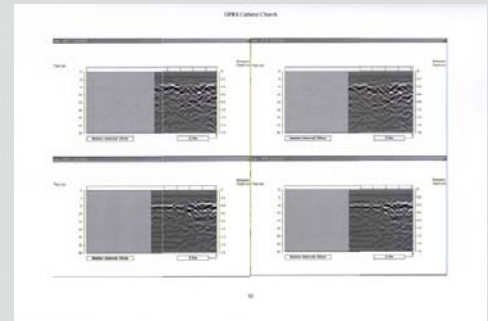
Ground radar survey, with the use of a 500MHz antenna system and a cable locator, to identify underground utilities and possible voids

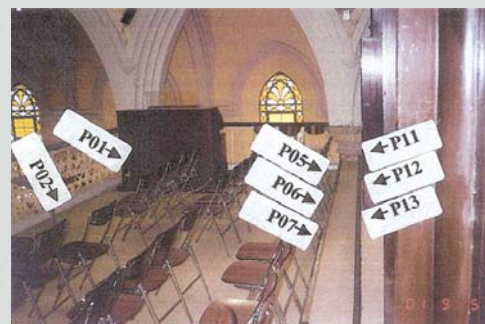
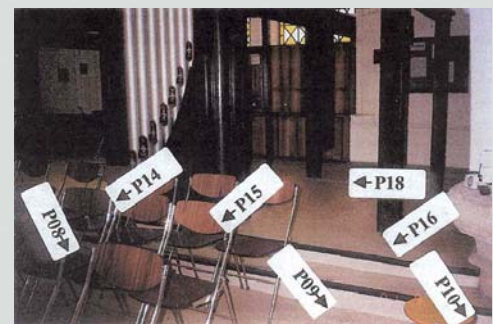
Photo records of monitoring check points

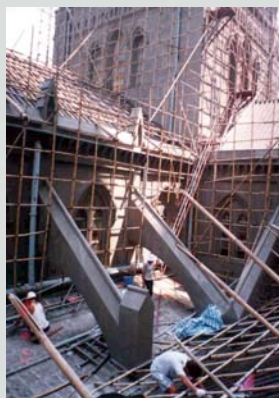
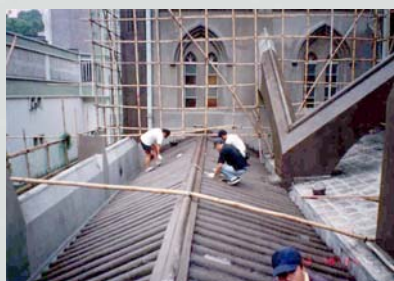
Application of SUNTEX waterproofing system

Before the complete overhaul of the entire roof, the material selected, " SUNTEX " waterproofing liquid membrane system, was applied over a small section of the roof over the transept for 2 years to test out its performance and compatibility before the main roof repairs were carried out from 1998 to 1999.

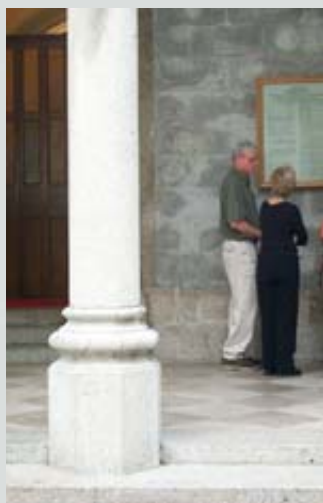
Granite paving at front Portico

The concrete floor paving at the front Portico, the side entrance and the entrance to the sacristy from the previous renovation was considered incompatible with the historic building. Granite paving similar to the granite used for the original stone columns and various related details was designed and laid by a specialist master mason, Mr. Arnaldo Acconci in the traditional manner.

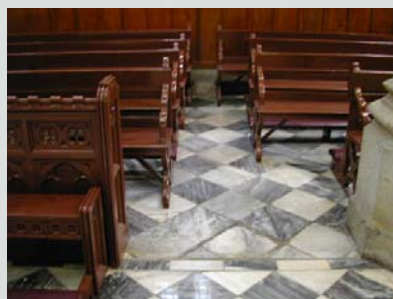
Broken marble tile under St. Joseph altar due to ground settlement

The Buildings Department had served a Dangerous Slope Order in 1998 for the slope of Caritas building adjoining the Cathedral, the ground settlement has led to the subsidence of floor at St. Joseph altar and the cracking of marble flooring. During the slope stabilization process, an old air-raid shelter was accidentally found which was left in-situ for future study.

During the repair of the internal marble flooring, salvaged floor tiles were used to match the existing flooring pattern. Where salvage tiles were insufficient to cover the floor paving at the St. Joseph altar, new marble tiles of matching colour to the oldest surviving flooring were laid to harmonize with the floor pattern.

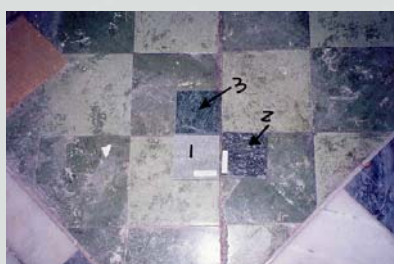
Selection of marble tile to match existing green tiles
